**WATERS OF THE U.S. DELINEATION REPORT
935 SPA ROAD
ANNE ARUNDEL COUNTY, MARYLAND**

ECS PROJECT NO. 47:2465

**FOR
MCCRONE ENGINEERING**

AUGUST 2, 2016

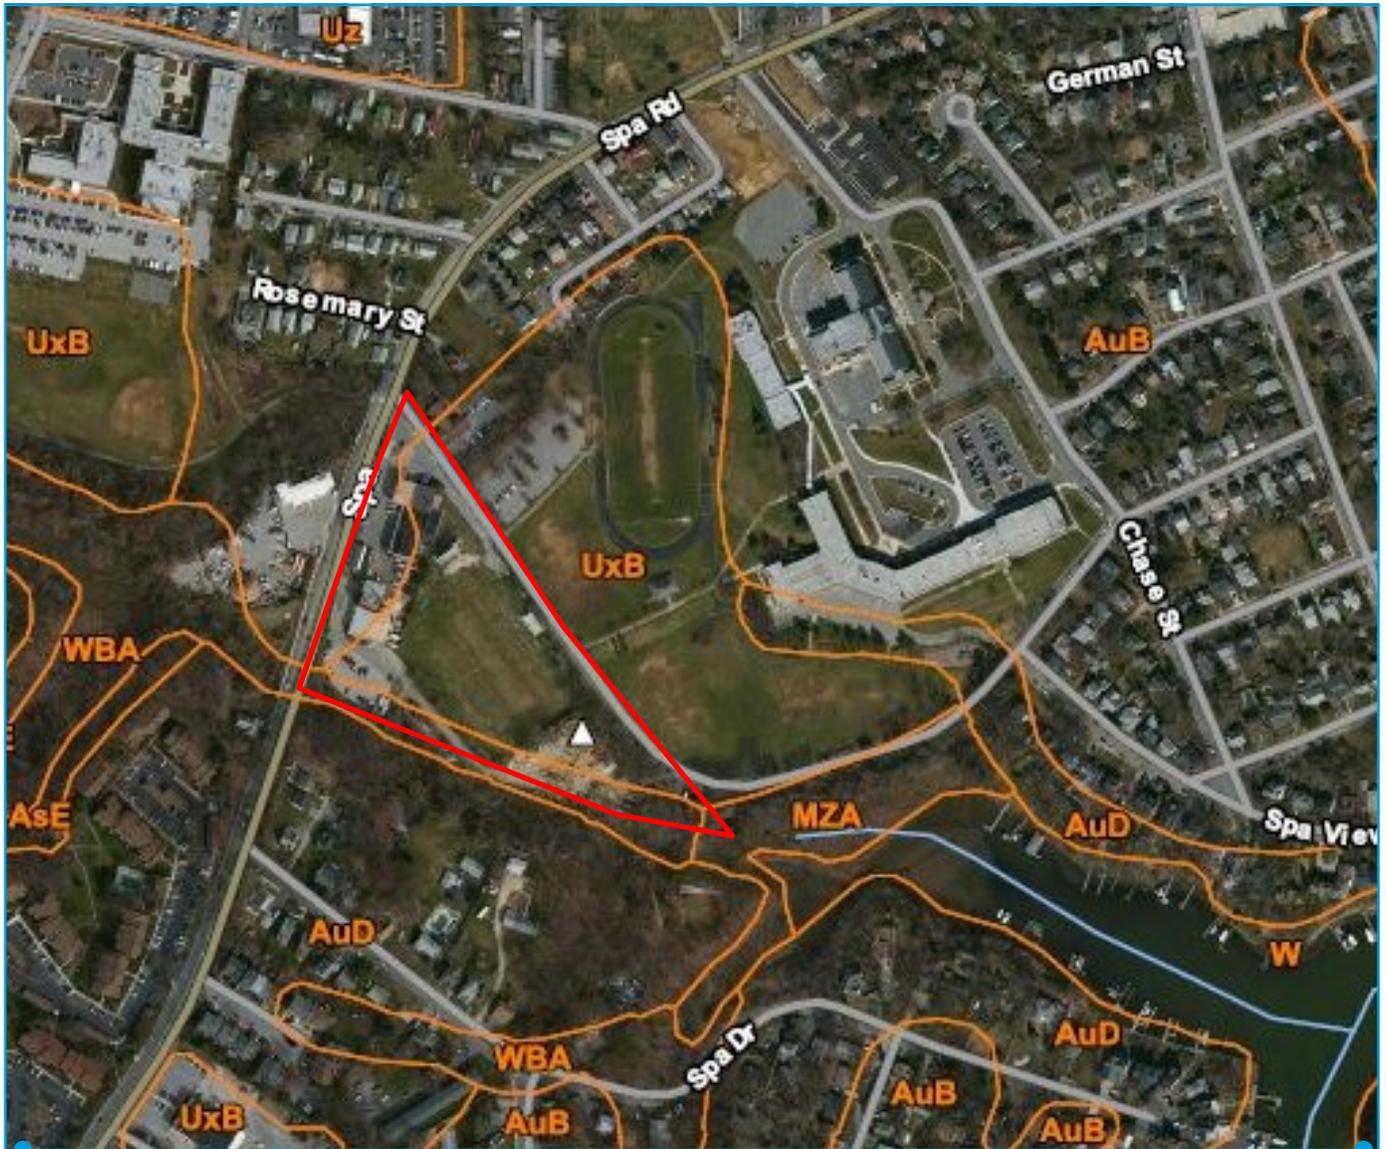
FIGURE III: USDA SOILS MAP
PROJECT #47:2465 — 935 SPA ROAD
CITY OF ANNAPOLIS, MARYLAND

A review of the Soil Survey for Anne Arundel County, Maryland identified five mapping units within the project site (Appendix III). These soil mapping units are: AuB – Annapolis-Urban land complex, 0 to 5 percent slopes, AuD – Annapolis-Urban land complex, 5 to 15 percent

slopes, MZA – Mispillion and Transquaking soils, 0 to 1 percent slopes, tidally flooded, UxB – Udorthents, loamy, sulfidic substratum, 0 to 5 percent slopes, and WBA – Widewater and Issue soils, 0 to 2 percent slopes, frequently flooded. Units MZA and WBA are classified as hydric by the NRCS.

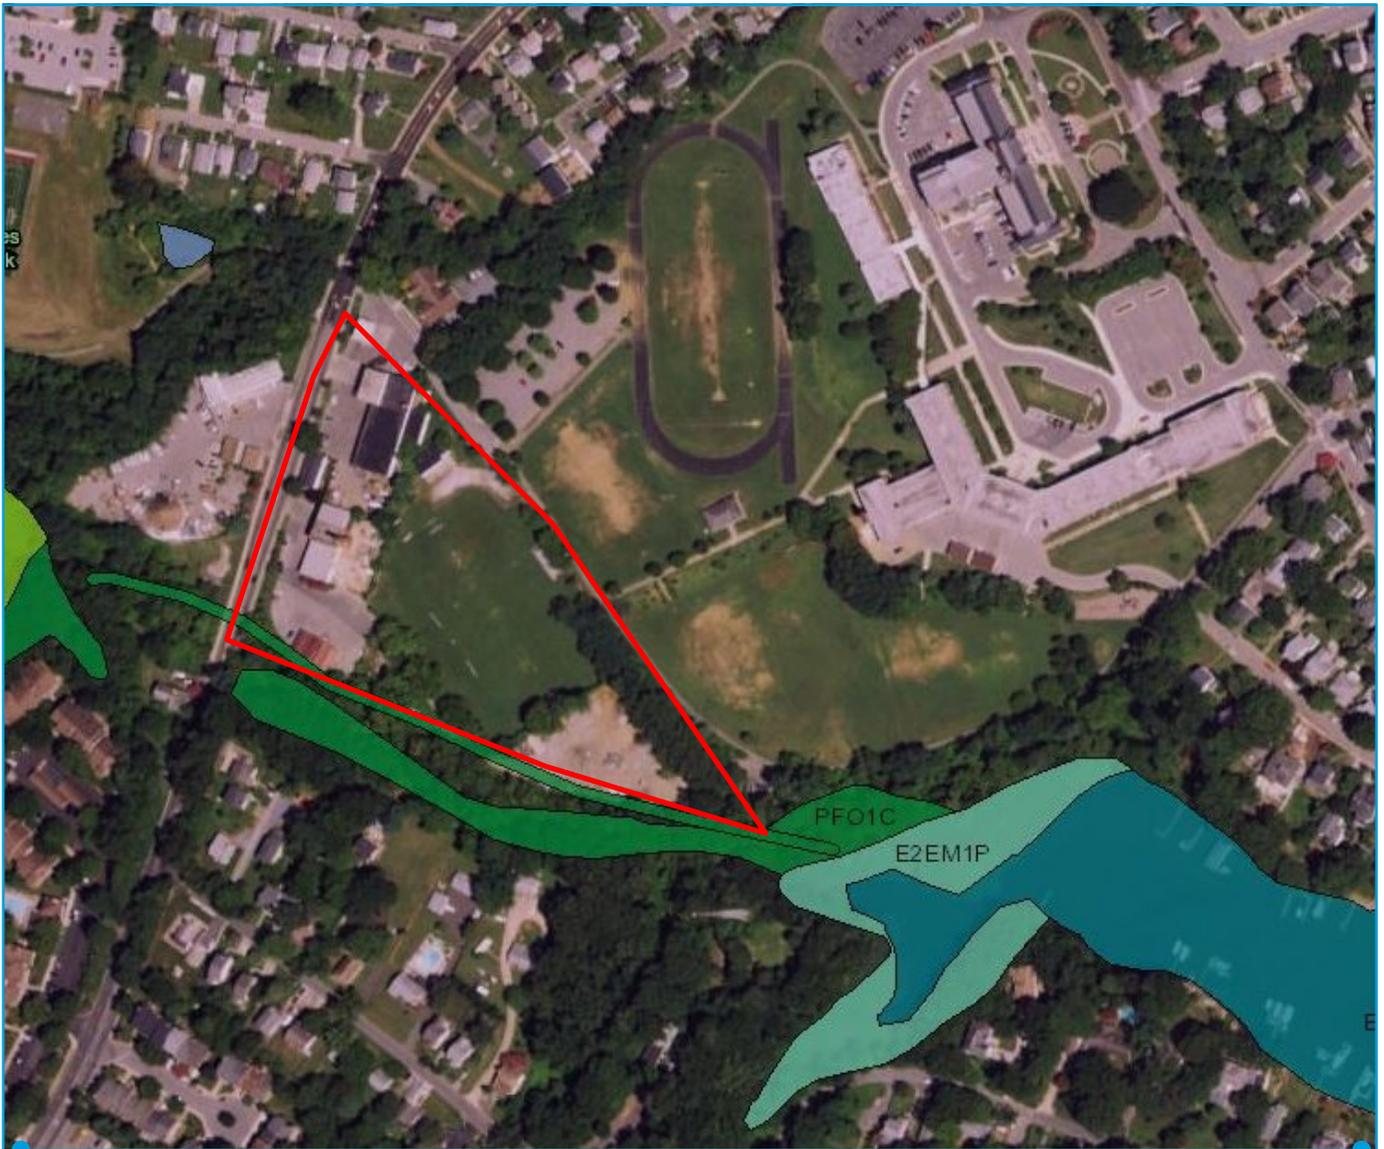
**FIGURE IV: NATIONAL WETLANDS INVENTORY MAP
PROJECT #47:2465 — 935 SPA ROAD
CITY OF ANNAPOLIS, MARYLAND**

The NWI map for Anne Arundel County, Maryland (Appendix IV) depicted several wetlands within the project study area, including palustrine forested and estuarine emergent wetlands. The USGS map (Appendix II) shows that the project site drains to Spa Creek, located within the Severn River watershed and identified as Hydrologic Unit Code (HUC) 02060004010. Elevations within the project site range from approximately 2 feet above mean sea level (MSL) in the southeastern portion of the property to approximately 42 feet above MSL in the northwestern portion.

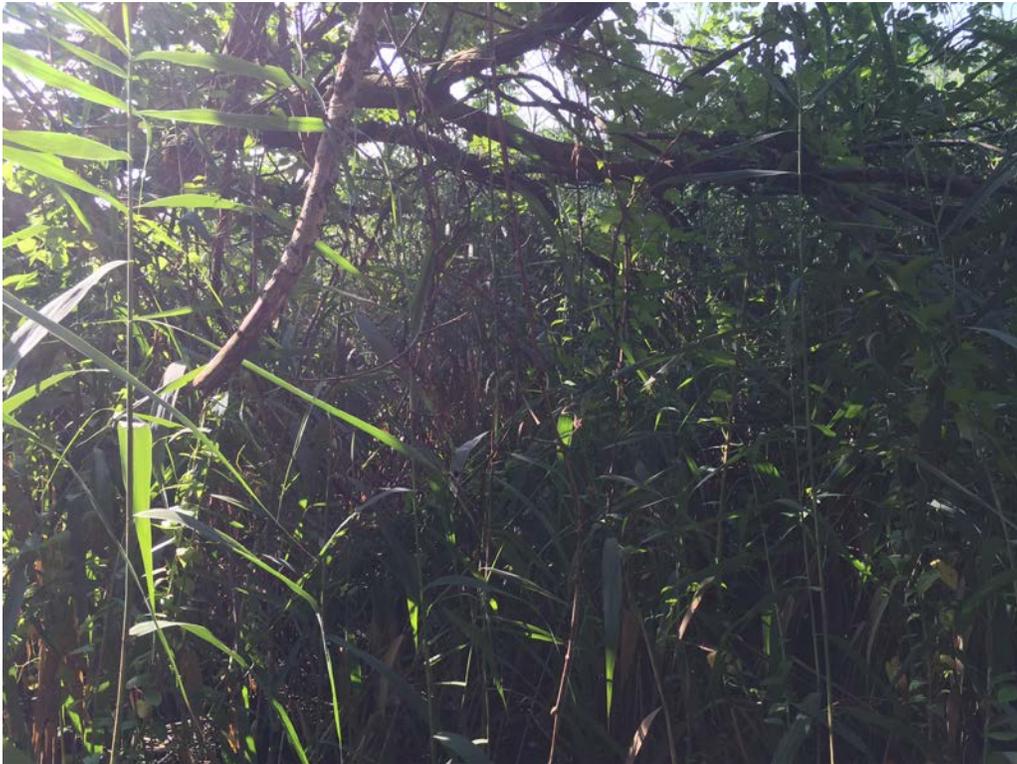
Photograph 1: Looking southeast at the estuarine forested (EFO) wetland, southeast of the study area.

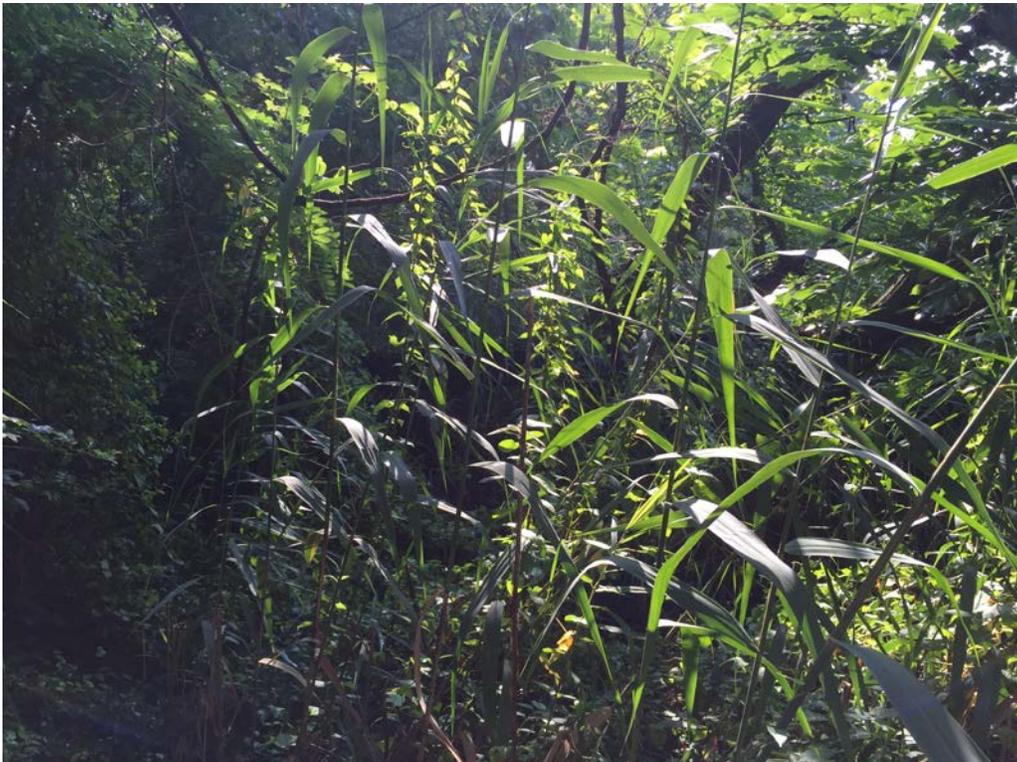
Photograph 2: Looking northeast along the boundary of the EFO wetland, southeast of the study area.

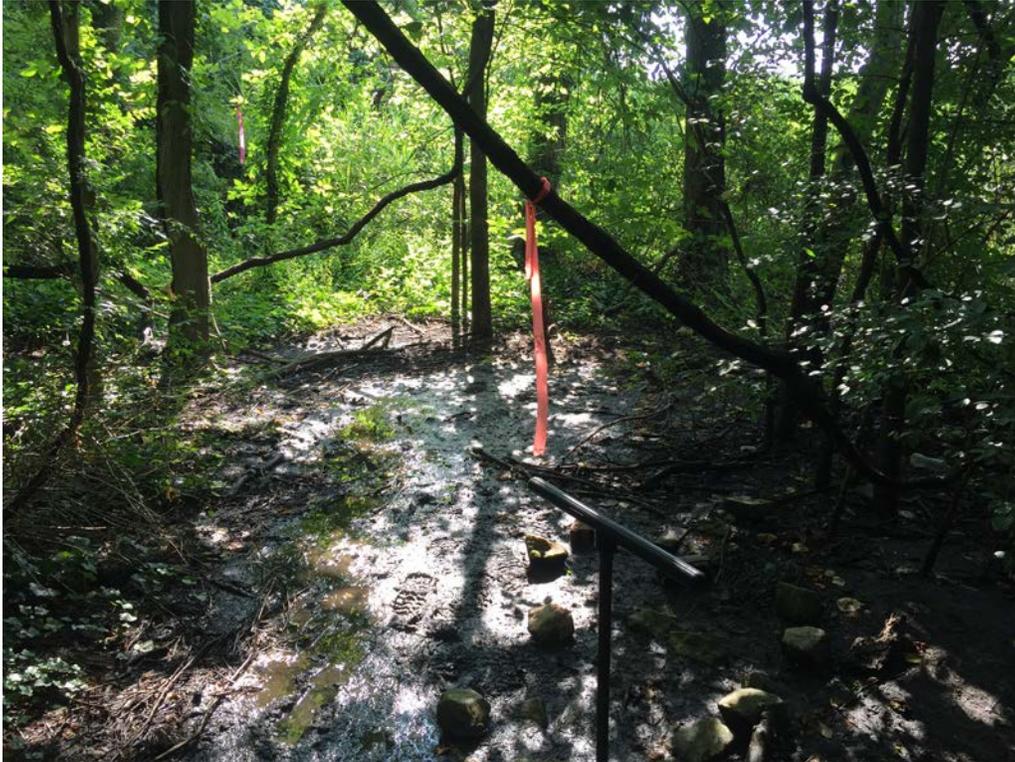
Photograph 3: Looking southeast at Data Point 1, which characterizes the EFO wetland southeast of the study area.

Hydrophytic Vegetation Present? Yes <u> X </u> No <u> </u> Hydric Soil Present? Yes <u> X </u> No <u> </u> Wetland Hydrology Present? Yes <u> X </u> No <u> </u>	Is the Sampled Area within a Wetland? Yes <u> X </u> No <u> </u>
Remarks: All three wetland parameters have been met at this Data Point location, which characterizes the estuarine forested wetland southeast of the study area.

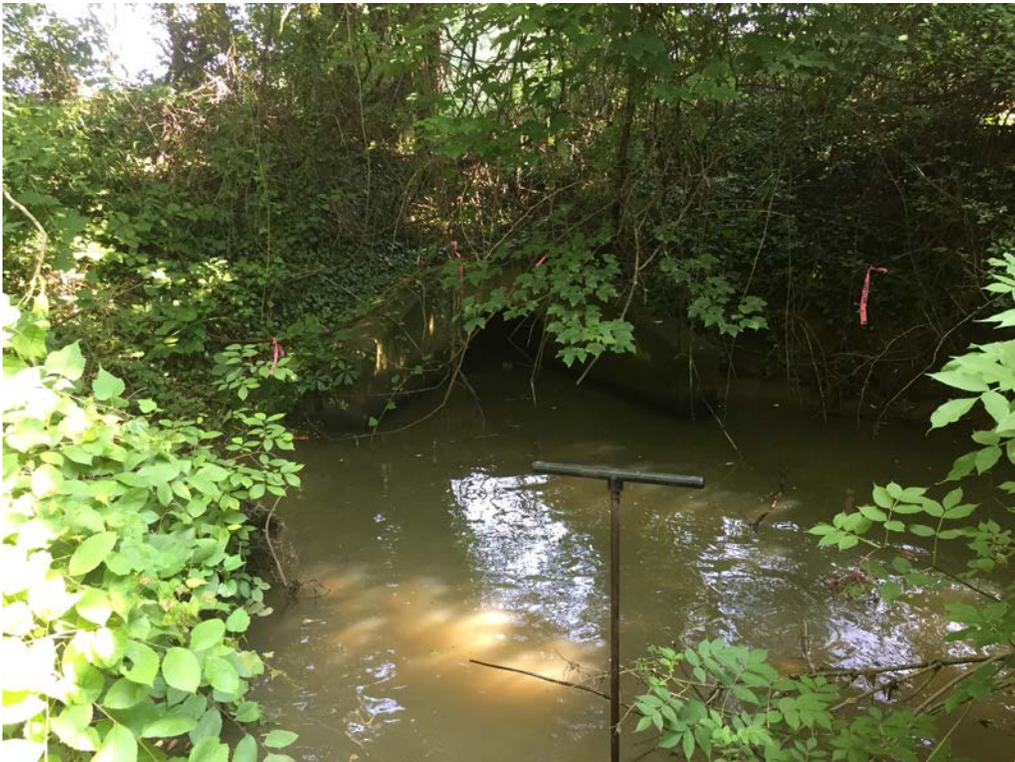
Photograph 4: Looking north at a culvert outlet southeast of the study area. This culvert appears to be the drainage outfall for the athletic fields present on the study area.

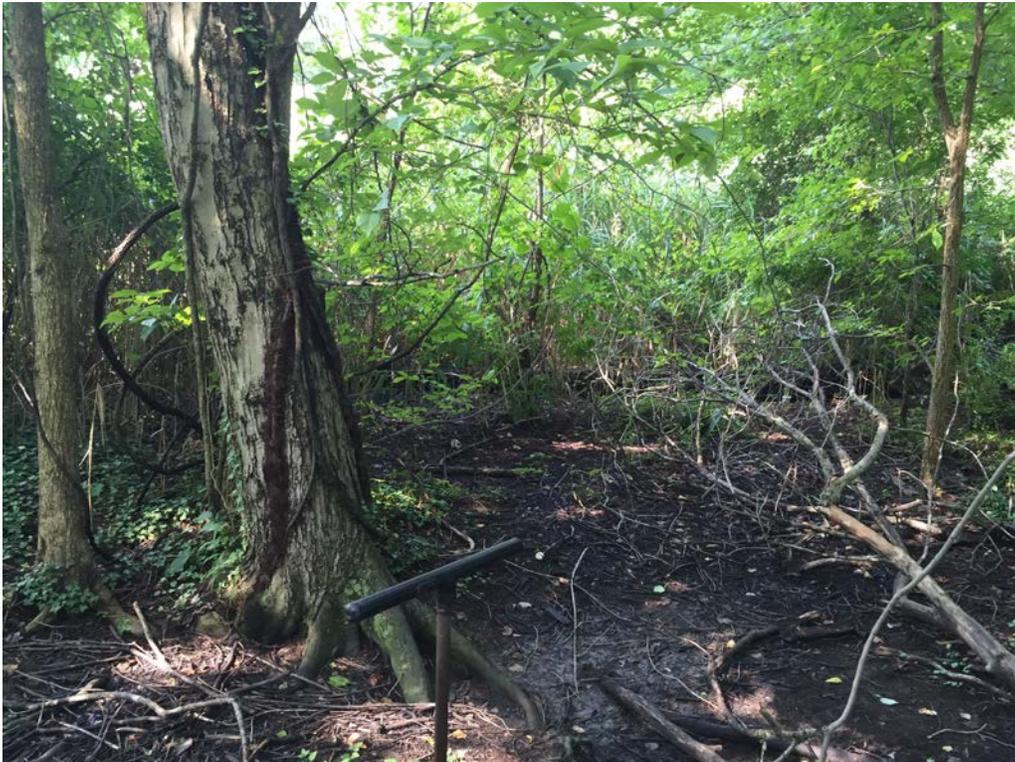
Photograph 5: Looking north at Data Point 2, which characterizes the non-wetland forest southeast of the study area.

Hydrophytic Vegetation Present? Yes <u> X </u> No <u> </u> Hydric Soil Present? Yes <u> X </u> No <u> </u> Wetland Hydrology Present? Yes <u> </u> No <u> X </u>	Is the Sampled Area within a Wetland? Yes <u> </u> No <u> X </u>
Remarks: Only two of the three wetland parameters have been met at this Data Point location, which characterizes the non-wetland forested area southeast of the study area.

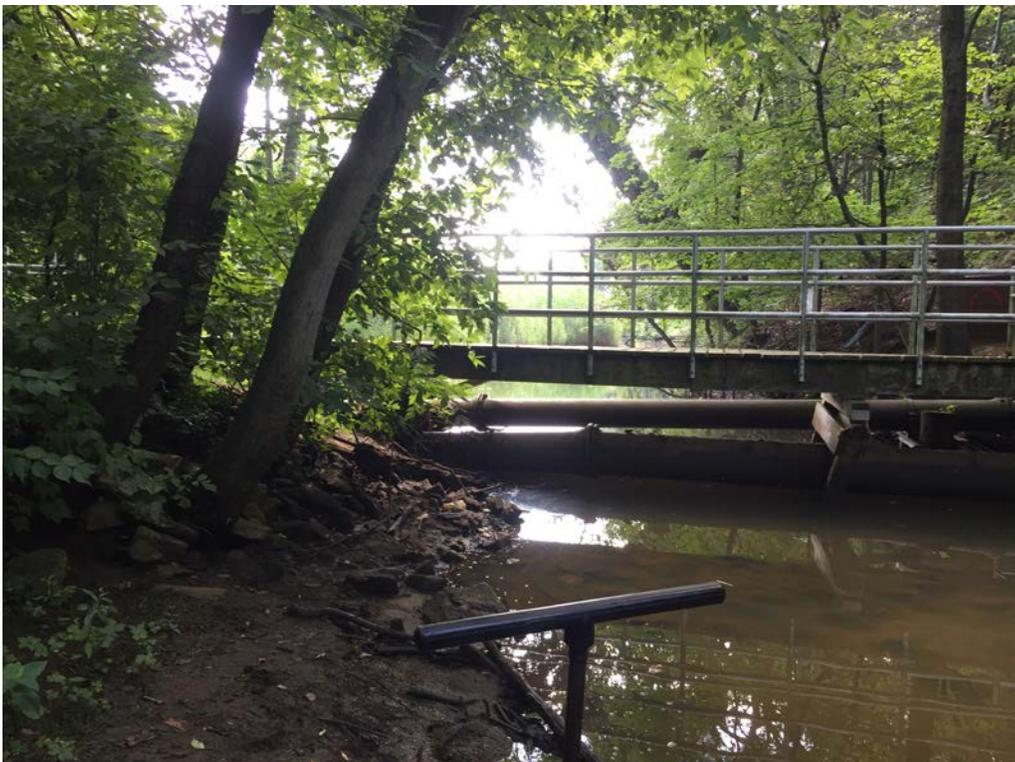
Photograph 6: Looking southeast (downstream) at Spa Creek, located on the southern portion of the study area.

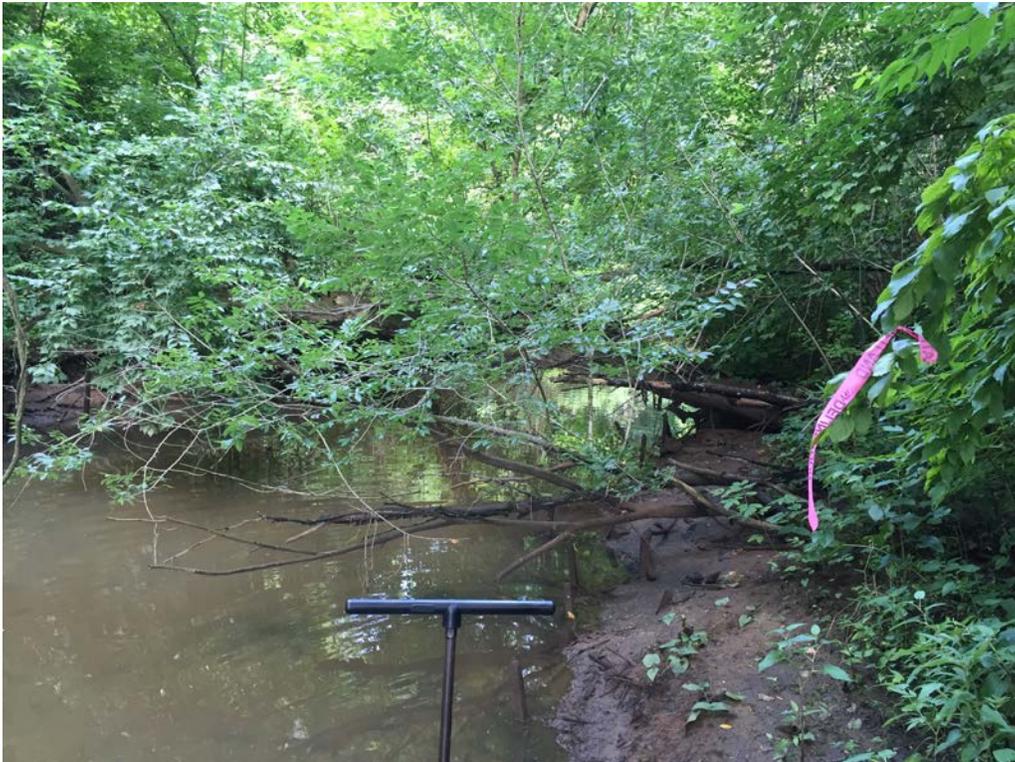
Photograph 7: Looking northwest (upstream) at Spa Creek.

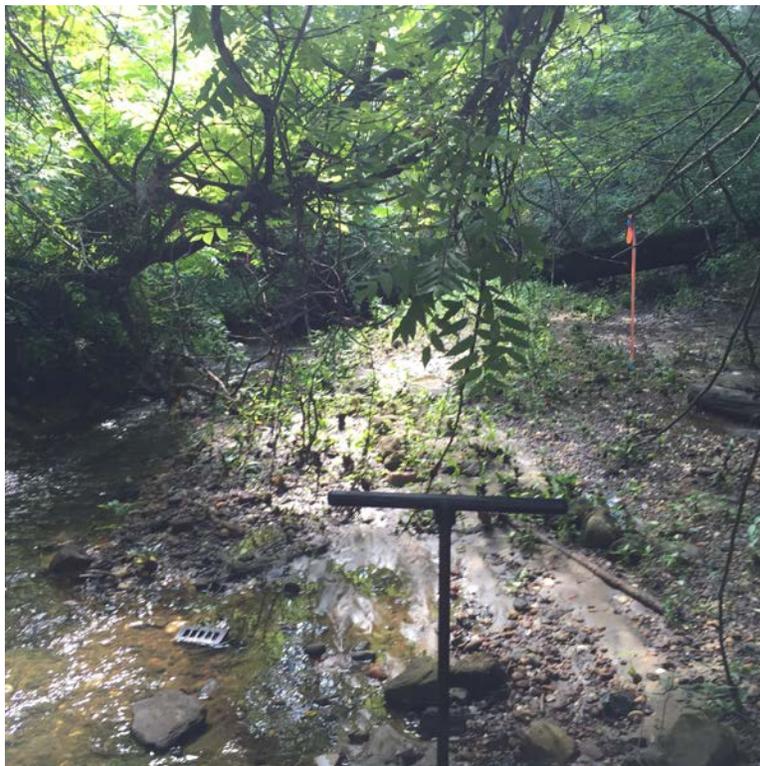
Photograph 8: Looking southeast (downstream) at Spa Creek, located on the southwestern portion of the study area.

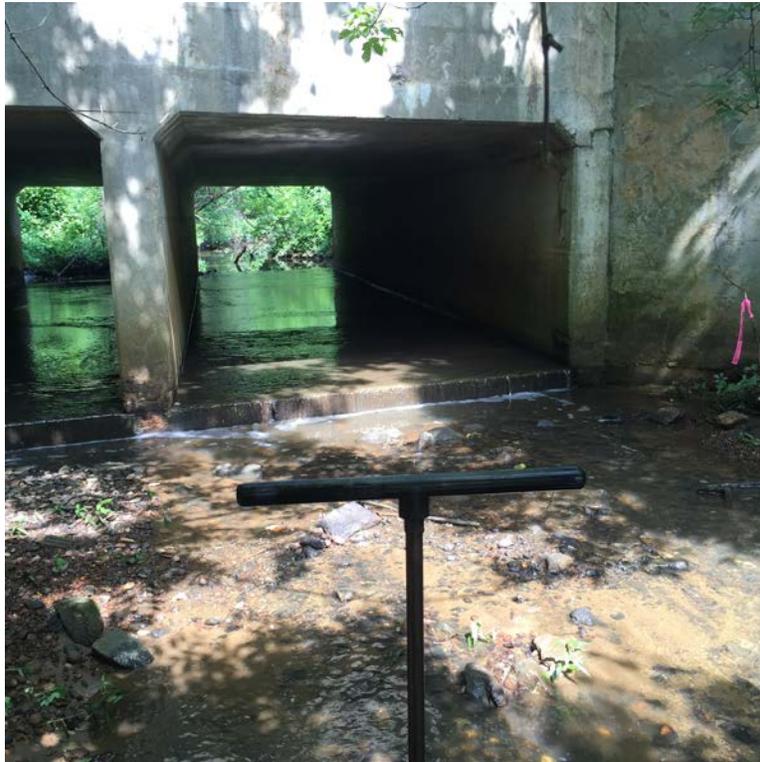
Photograph 9: Looking northwest (upstream) at Spa Creek.

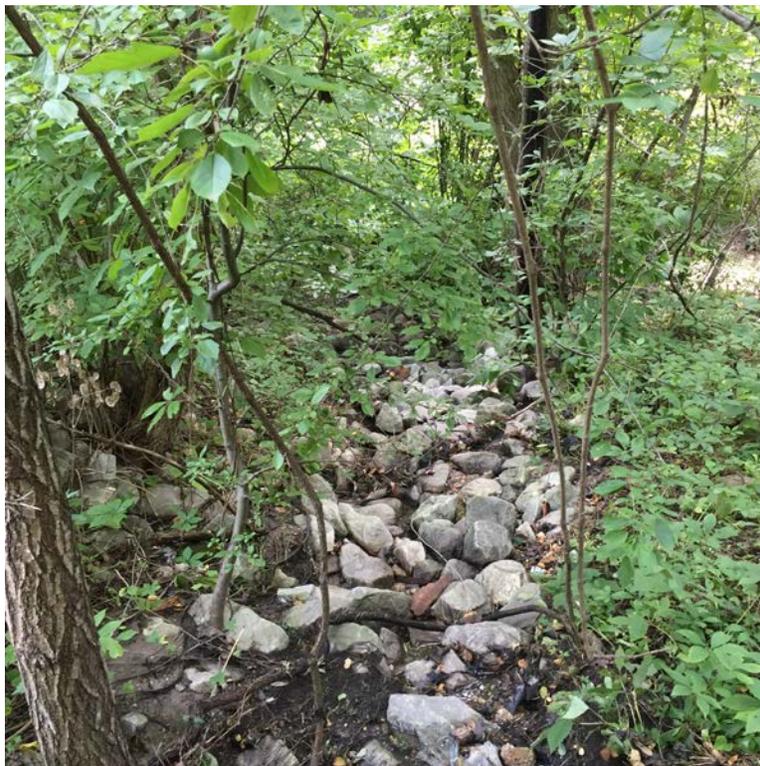
Photograph 10: Looking southeast (downslope) at the non-jurisdictional stormwater drainage located in the southwestern portion of the study area (subject to USACE concurrence).

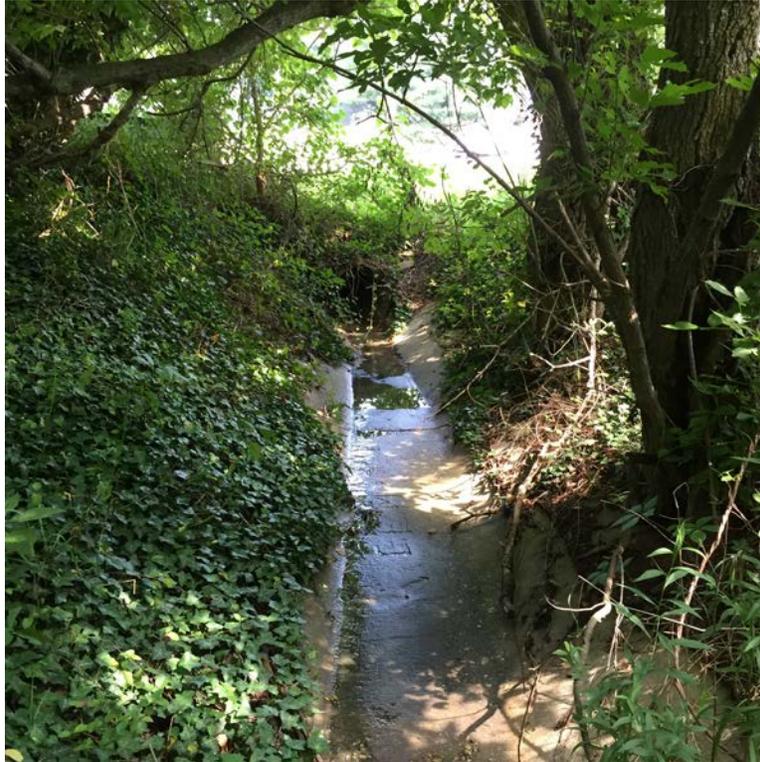
Photograph 11: Looking northwest (upslope) at the non-jurisdictional stormwater drainage located in the southwestern portion of the study area (subject to USACE concurrence).

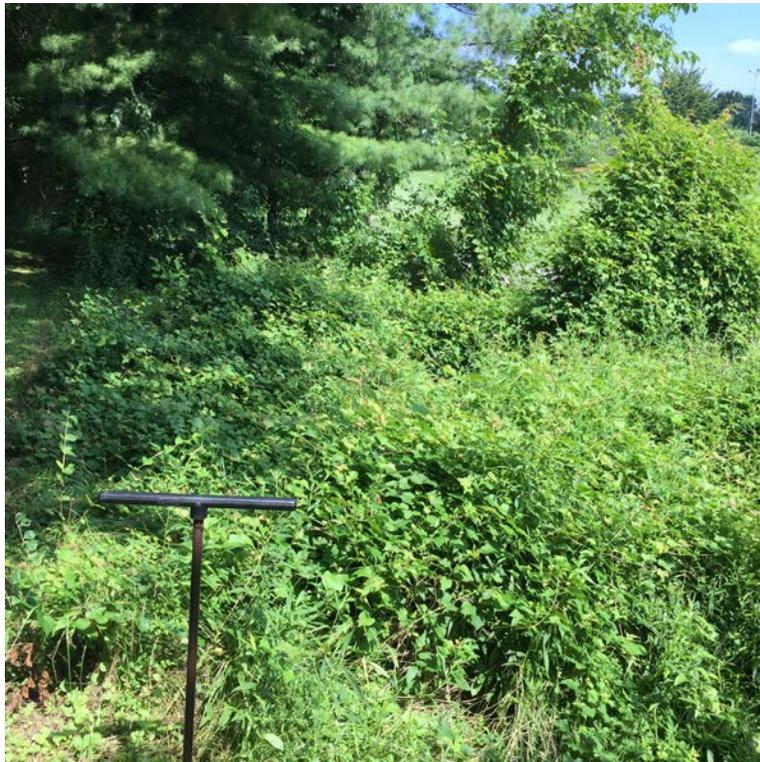
Photograph 12: Looking northwest at the non-jurisdictional drainage swale located in the southeastern portion of the study area. This drainage swale appears to outlet at the culvert pictured in Photograph 4.

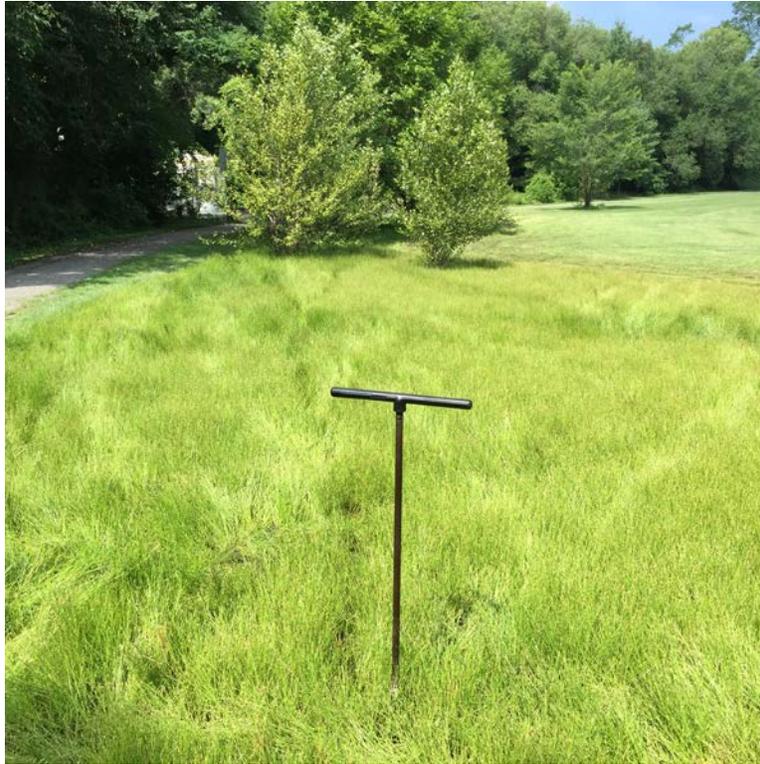
Photograph 13: Looking northwest at Data Point 3, which characterizes the upland field just east of the study area. Although this area exhibits some wetland characteristics, it appears to be highly disturbed. The land appears to have been graded to make an athletic field, as well as for the paved trail around the field. This trail appears to be inhibiting overland drainage, causing water to pool around the outer extents of the vegetated area where the field abuts the paved trail. As a result of the athletic field, the vegetation is mowed and maintained.

Hydrophytic Vegetation Present? Yes <u> X </u> No <u> </u> Hydric Soil Present? Yes <u> </u> No <u> X </u> Wetland Hydrology Present? Yes <u> X </u> No <u> </u>	Is the Sampled Area within a Wetland? Yes <u> </u> No <u> X </u>
Remarks: Only two of the three wetland parameters have been met at this Data Point location, characterizing the upland field east of the study area. Although this area exhibits some wetland characteristics, it appears to be highly disturbed. The land appears to have been graded to make an athletic field, as well as for the paved trail around the field. This trail appears to be inhibiting overland drainage, causing water to pool around the outer extents of the vegetated area where the field abuts the paved trail. As a result of the athletic field, the vegetation is mowed and maintained.

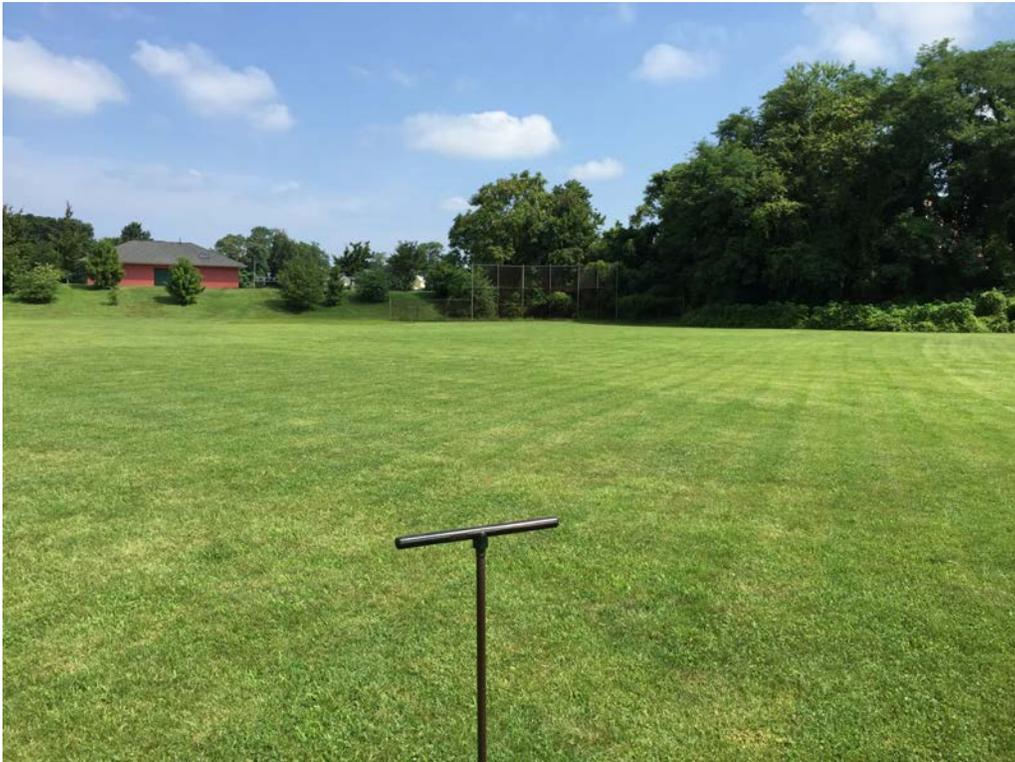
Photograph 14: Looking north at the maintained athletic field located along the eastern boundary of the study area.

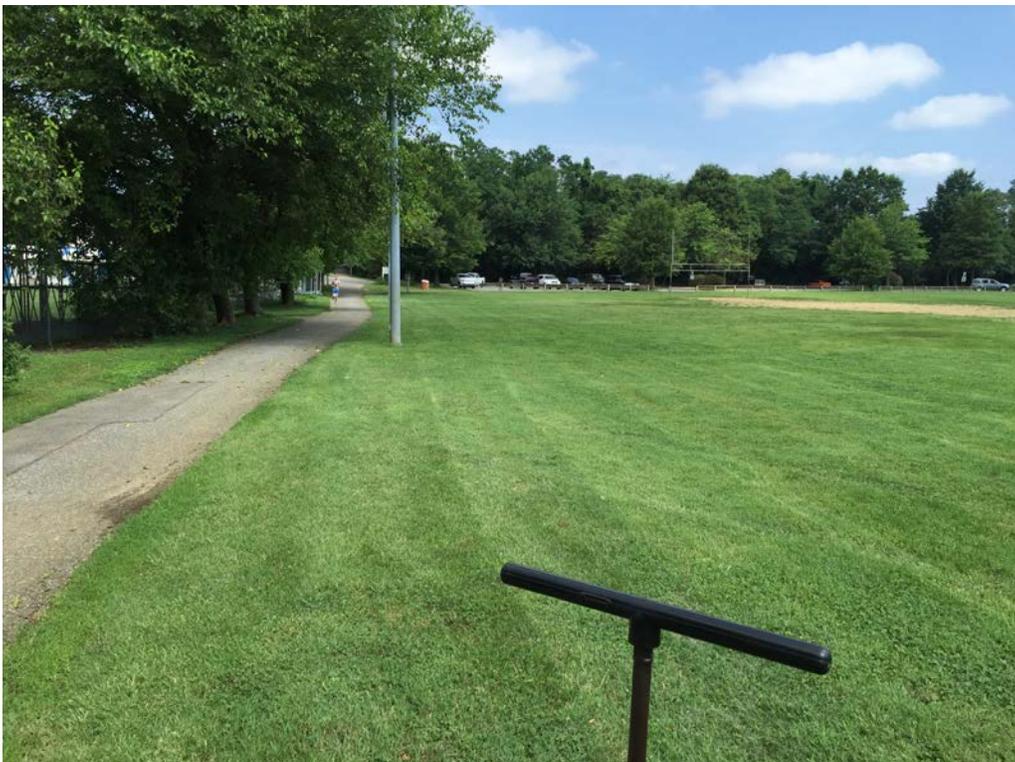
Photograph 15: Looking northwest at the maintained athletic field located along the northeastern boundary of the study area. The majority of the study area is composed of maintained, athletic facilities, paved parking area, and buildings.

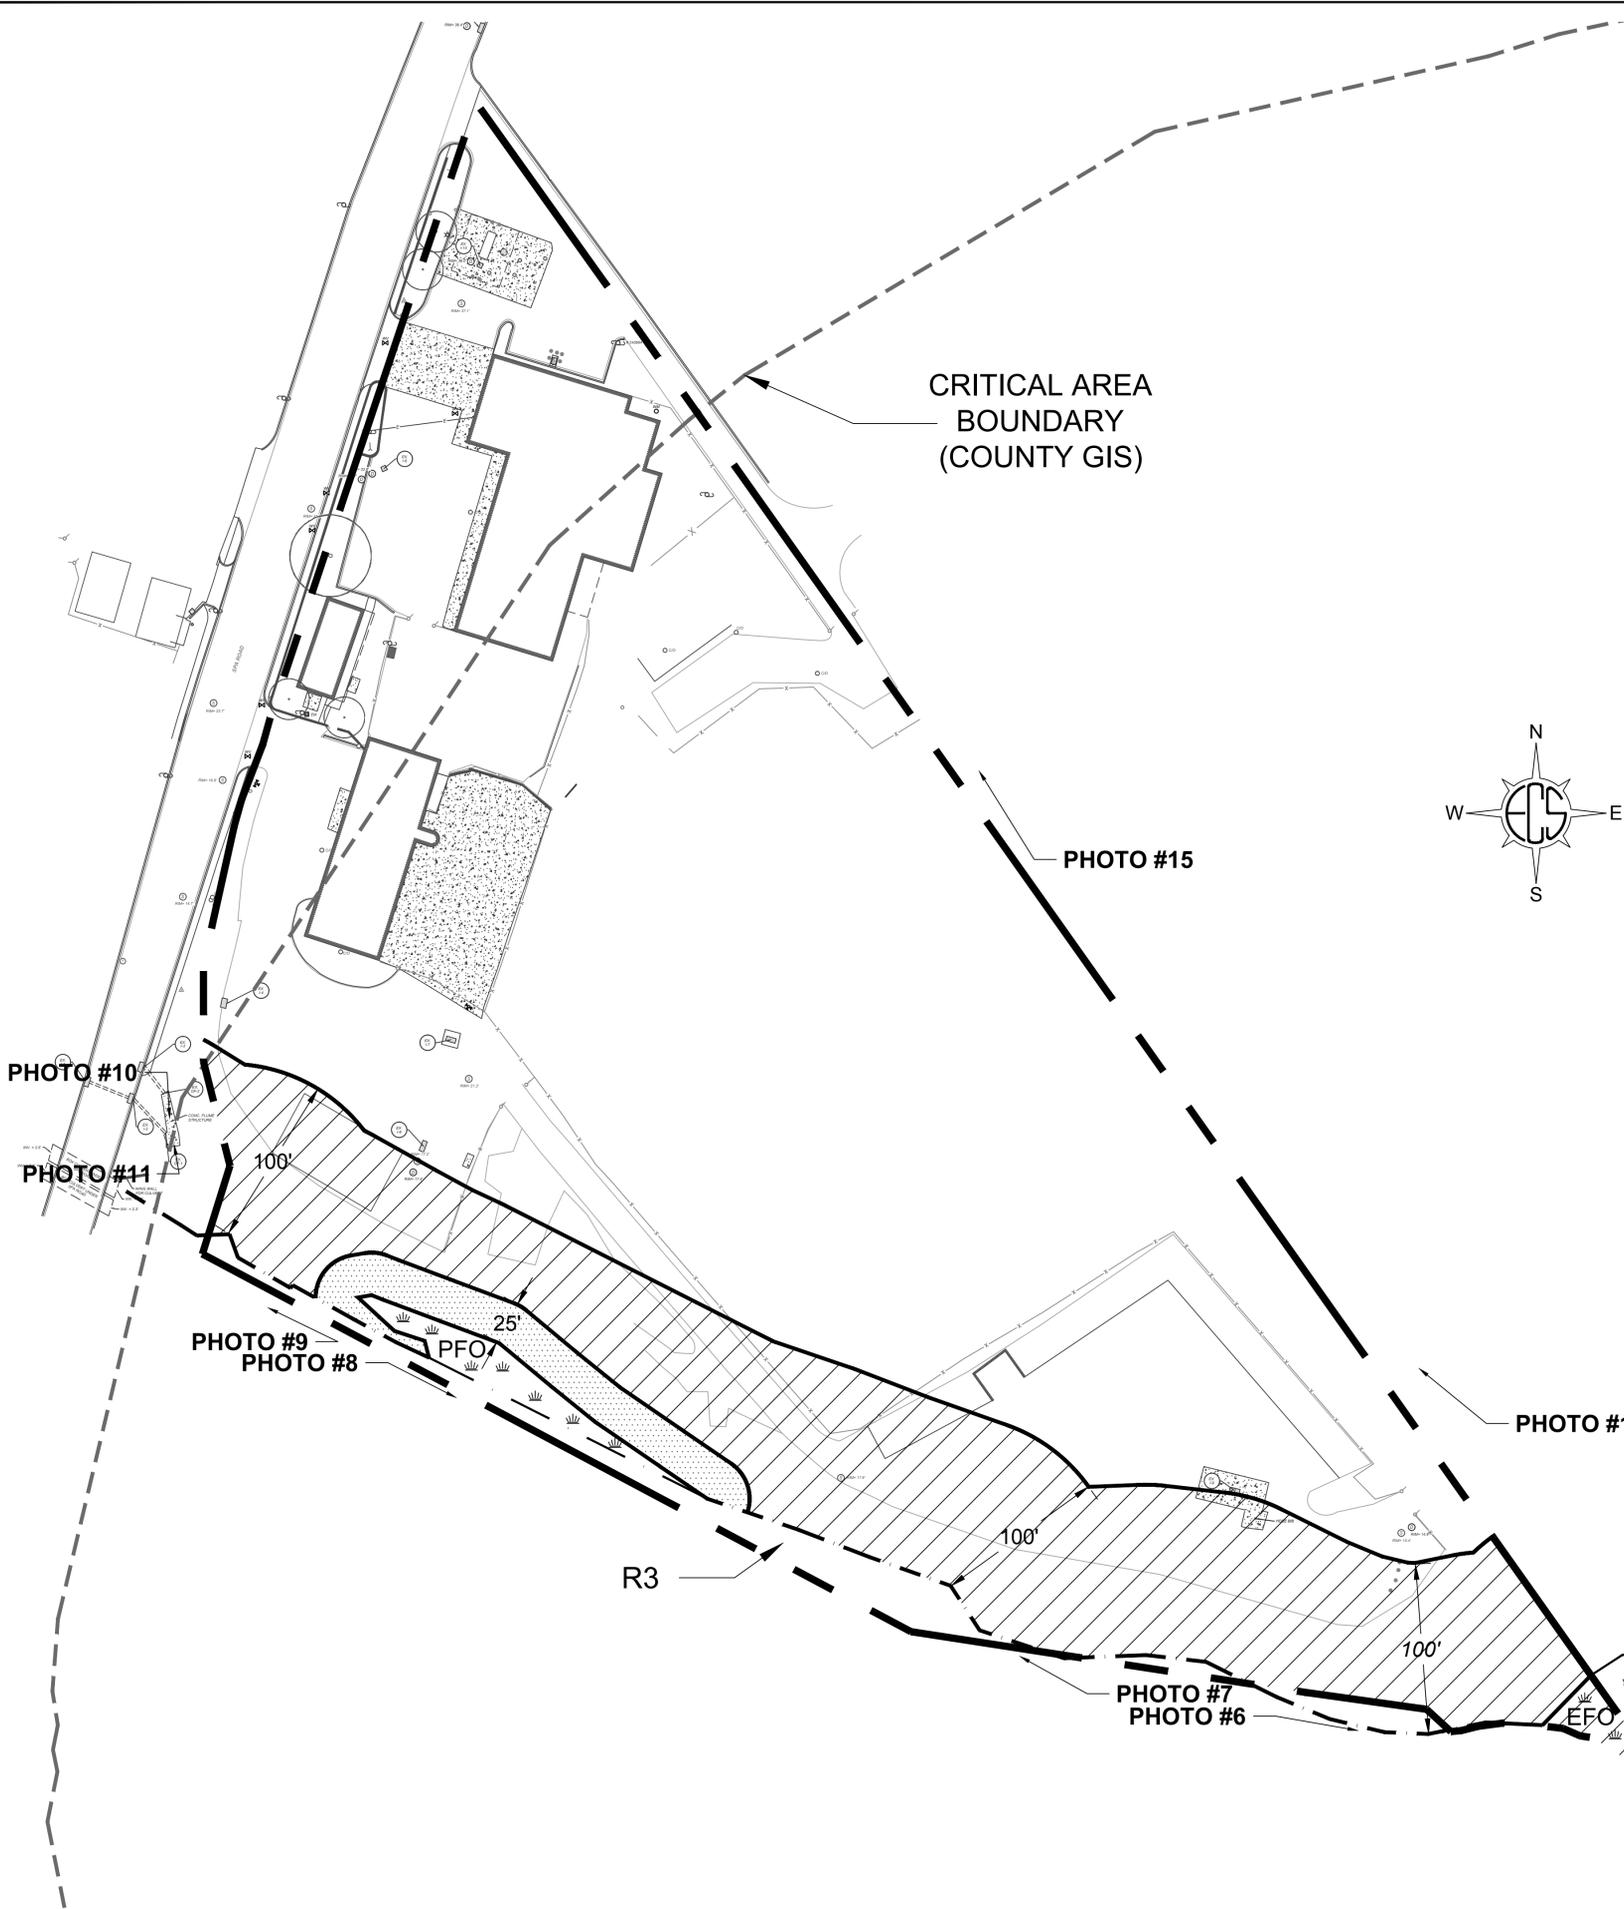
WATERS OF THE U.S. DELINEATION MAP

In ECS’ opinion, jurisdictional WOUS are present within the 935 Spa Road study area. These WOUS include a perennial reach of Spa Creek located in the southern and southwestern portions of the study area, as well as one EFO wetland located in the southeastern portion of the study area and one PFO wetland located in the southwestern portion of the study area. The EFO wetland extends off-site to the southeast. Their size and USFWS Cowardin classifications are summarized below (Table 1), and their locations are illustrated on the Waters of the U.S. Delineation Map (Appendix X).

Two potentially jurisdictional wetlands totaling 0.10 acres were identified and delineated within the 935 Spa Road study area. One potentially jurisdictional stream totaling 624 linear feet was also identified on the study area. The locations and boundaries of jurisdictional Waters are illustrated on the attached Waters of the U.S. Delineation Map (Appendix X).

A Chesapeake Bay Critical Area is believed to be present on the majority of this study area (Appendix VII). Similarly, the City of Annapolis and MDE regulations will result in a 100-foot non-tidal stream buffer adjacent to the jurisdictional non-tidal perennial portion of Spa Creek located in the southern and southwestern portions of the study area, as well as where Spa Creek flows into the tidal estuarine forested wetland in the southeastern tip of the study area. A 25-foot non-tidal wetland buffer will also exist off the PFO wetland boundary in the southwestern portion of the study area. These buffers are shown on the Waters of the U.S. Delineation Map (Appendix X).
